#### The Arizona Asphalt-Rubber Project Review

#### **Evaluation of A-R Pavements Constructed Before 1992**

This paper is part of The Arizona Asphalt-Rubber Project Review
Sponsored by:
Arizona Department of Transportation and the Rubber Pavements Association

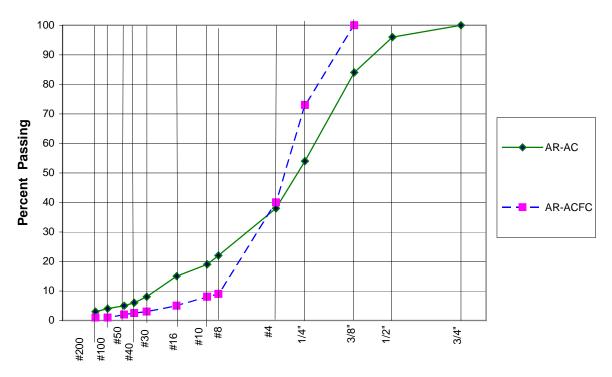
FIGURE 1 Aggregate gradations for Gap and Open mixtures

# Arizona D.O.T , Materials Group AR-AC & AR-ACFC Gradation Chart

Sieve Sizes to 0.45 Power

Two different hot mix designs are used, dependent on pavement type, field conditions, and climate. One mix, used solely as a surface course, is an open-graded mixture with design air voids of a minimum of 15%. This mix generally has 9% or more binder and has high friction characteristics. The second mix is essentially a dense graded mixture designed to have approximately 5% air voids. However, portions of the smaller aggregate and fines in this mixture are significantly reduced to provide a gap grading. The product is very similar to what is known as a stone-mastic (SMA) mixture with the elastic reacted rubber used in place of inert fillers. The binder content in this mix will generally fall between 7.5 and 8.5%. A comparison of the aggregate gradations for Gap and Open mixtures is exhibited in Figure 1. ADOT nomenclature for the open graded mix is Asphalt-Rubber, Asphalt Concrete Friction Course (AR-ACFC). The Gap-graded mix is Asphalt-Rubber, Asphalt Concrete (AR-AC). The specifications used by ADOT for the A-R binder and mixes are provided in Appendix A.

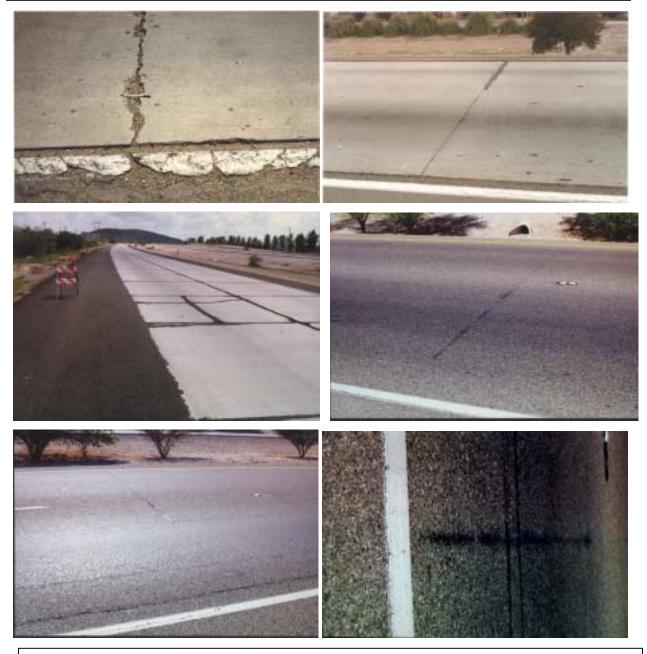
FIGURE 2 Interstate 19, Tucson South MP 58-60 constructed 1988

First three images from top to bottom and left to right are archive photographs from 1986, the third picture of crack sealing prior to overlay in 1988.

The last three photographs are typical of the joints reflecting through the overlay. The crack width is less than ¼ inch. In most cases the joints are still closed with the crack sealant "wicking" through the thin overlay. Photos taken in April 2000.

At the time of placement the design binder content was 10%. With this open-graded mix this correlates with an aggregate volume of 55%, binder volume of 25%, and air voids of 20%. In the 12 years of service the air voids have decreased to 15%. The original binder at time of placement had a penetration of 48 and a softening point of 140°F. After 12 years of service the penetration has decreased to 22 and the softening point increased to 160°F. This represents excellent resistance to aging. This inspection concluded that this overlay is still in excellent condition. There is no discernable rutting nor is there any evidence of maintenance repairs. There is a very limited number of reflective cracks above the underlying joints and these cracks are all hairline in width or they are "ghost" cracks and are completely closed in the wheel paths. Noise measurements were not made but there is a very discernable difference in noise level between this pavement and the adjacent concrete pavements. The overlay mixture is still alive and exhibits a high level of elastic rebound. Before and after photographs are presented as Figure

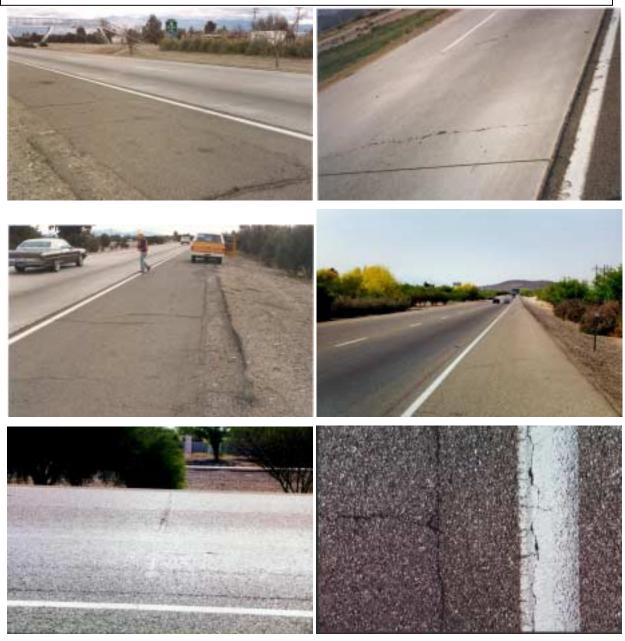
FIGURE 3 Interstate 19, Irvington Road – I-49 MP 60-64 constructed 1991

Top Row and Middle Left - PCCP before overlay. Middle Right – Typical pavement appearance after nine years. Bottom Left - The cracking above joints is typically less than  $\frac{1}{4}$  inch, the cracks remain closed and have very little or no spalling with excellent rock retention. Bottom Right – An example of the worst case of cracking.

In 1991 an additional four-miles of I-19 was resurfaced with the same type of overlay. This project has the same traffic and environmental exposure as the one previously discussed. At present this pavement has less than 2% reflective cracking with no visible maintenance. Cracks appear above some joints but have not required any maintenance activities such as crack filling or patching. Those cracks that have reflected through, are closed in the wheel paths, and do not appear to suffer from spalling or loss of material. The binder appears to be holding the mix together very well on both sides of these hairline cracks. The worst case of cracking on this project is exhibited in Figure 3, which also includes a representative "before" photographs. The PMS data is similar to the earlier and adjoining project and is represented in Table 2. The high maintenance costs before the overlay are representative of repairs made to approximately eight concrete slabs which had experienced faulting according to the ADOT project materials design memorandum dated January 11, 1991.

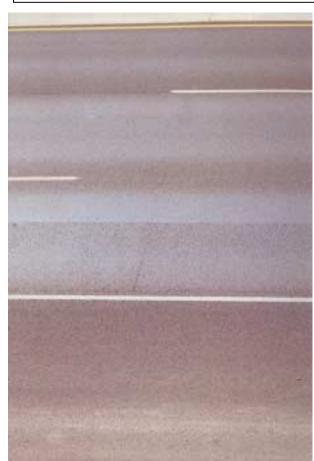
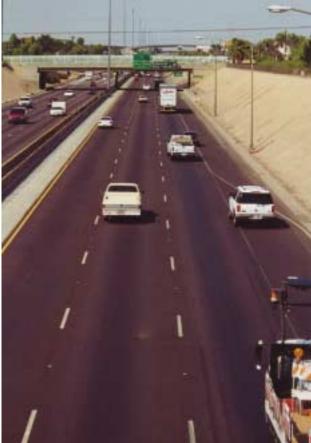
FIGURE 4 Interstate 17, Buckeye Rd. – Van Buren MP 198.2-199.8 constructed 1990

- 1) All joints had reflected through in the distress lanes and the shoulder but the cracks were either closed or hairline in the travel lanes.
- 2) Some structural failure is occurring with three potholes developing. The holes are relatively inline with each other. The pattern suggests underlying repair work to the longitudinal joints prior to the overlay.
- 3) Noise reduction is good.
- 4) Ride is smooth and rutting is insignificant.
- 5) Overlay color is still a very dark black which provides good contrast to pavement markings, striping, and reflectors.

Above - Photos before overlay indicating patch work along joints and faulting. Below - photos taken in 2000, ten years of service, with very little cracking evident. Note the "pot hole" in the lower right photo probably due to failure of patching material. About five such "pot holes" are present in the North Bound lanes.

Photographs from the recent inspection are displayed in Figure 4. All in all this pavement is in good condition and the overlay has provided excellent service over it's ten year life.

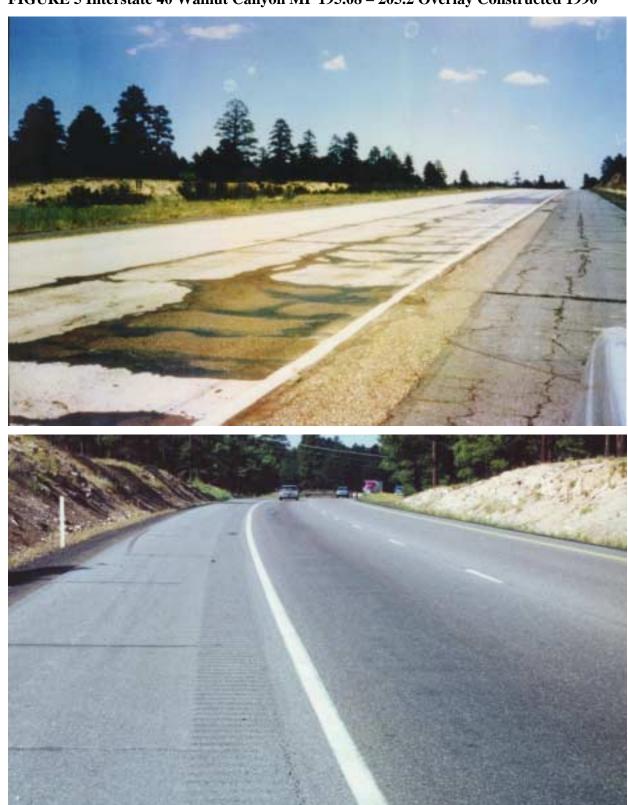
FIGURE 5 Interstate 40 Walnut Canyon MP 195.08 – 205.2 Overlay Constructed 1990

The performance of this design has been phenomenal. The 1998 PMS data show 0% percent reflective cracking, IRI of 63 in/mile, rut depths of .11 inches, skid resistance of 65, maintenance costs per mile ranged from 0 in 1990 to \$852 in 1998. The project performance values are contained in Table 4 below. Photographs of the project are exhibited in Figure 5.

The inspection in the year 2000 verified this performance. Reflective cracking is still near zero and the ride is excellent. Maintenance activities are primarily on the shoulders and within localized areas which are discussed next.

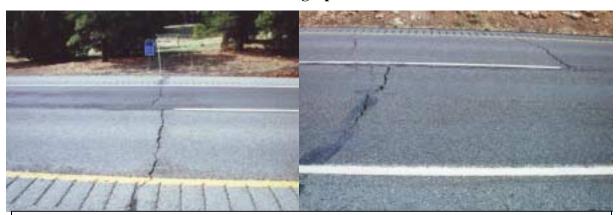
FIGURE 7 Interstate 40 Test Section Photographs

State Test Section 040660, 8 inch conventional AC overlay of rubbilized PCCP – "has transverse cracks at 50 feet spacing which are one half inch to one inch wide. Longitudinal cracking occurs at the centerline and between wheel paths. Ride is already rough. It is estimated that the pavement will have to be replaced within 2 years."

SHRP Test Section 040607, 4 inch overlay of Cracked and Seated PCCP - "this pavement has one inch wide cracking at approximately 12 feet centers and longitudinal cracking at the center line. Cracks are spalling in the travel lane."

From left to right: State Test Section 040660 - 8 inch conventional AC overlay of rubbilized PCCP, SHRP Test Section 040607 - 4 inch AC overlay of cracked and seated PCCP

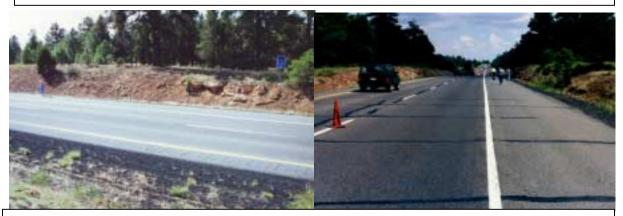
State Test Section 040661, two inch ARAC, over two inch AC, C and S PCCP - "this pavement is in excellent condition, it has a few 1/8 inch wide transverse cracks and hairline longitudinal cracks between wheel paths, no spalling, little maintenance evident on driving lanes, some crack sealing on the shoulder lane."

SHRP Test section 40604, four inch AC overlay, saw and seal joints. "The joints have reflected through and are open ½ to 2 inches. They have been resealed but exhibit extensive spalling. There are continuous, wide, longitudinal cracks at the center line. Some rutting is evident."

From left to right: State Test Section 040661 - 2 inch ARAC overlay and 2 inch AC leveling course on cracked and seated PCCP, SHRP Test Section 040604 – 4 inch AC overlay of saw and sealed joints in PCCP.

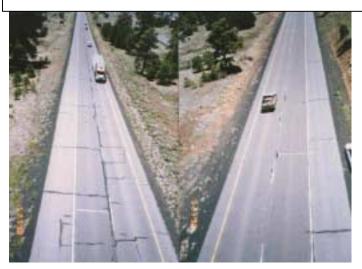
Left - Comparison photographs of Section 040659, 4" OL over Crack and Seat PCCP on left and Section 040661, 2" ARAC over 2" AC over Crack and Seat PCCP on right. The photographs were taken from a "cherry picker" sixty feet above the pavement surface in 1998, after eight years of performance.

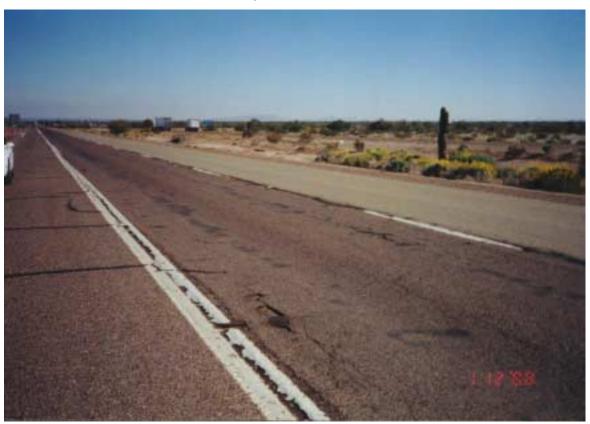
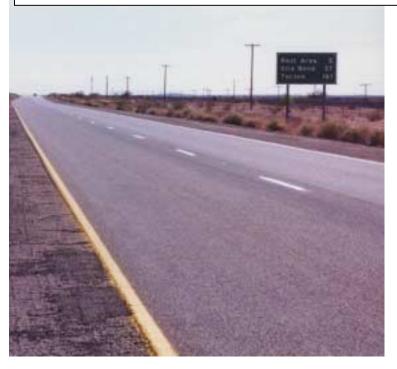
FIGURE 8 Interstate 8, Aztec County Line MP 72-82, constructed 1990

The first friction course placed over aged AC is located between Gila Bend and Yuma, a desolate, extreme desert climate. The area is at an elevation of 870 and has maximum temperature of 120°F. This region is often reported as the hottest in the USA in the summer months. In 1990, the existing pavement was badly cracked, a ride of 70, with rut depth 0.36 inches and maintenance cost running \$1841 per lane mile. The rehabilitation design for this project consisted of a four inch AC overlay with a ½ inch AR-ACFC. Project photographs are contained in Figure 8. After 10 years of service the pavement had 3% cracking, a ride of 46, rut depth of 0.05 inches, and maintenance costs average of \$126.20 per lane mile. There is no bleeding and skid resistance is still very high with a Mu meter reading of 60. See Table 5 for project data.

Above – Conditions prior to overlay. Bottom Right – Typical pavement condition 2000. Bottom right - shoulder crack stopping at AR-ACFC)

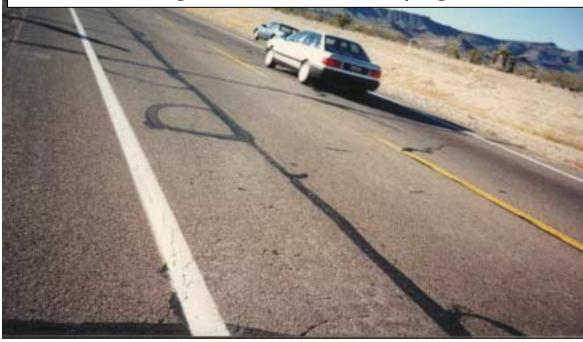
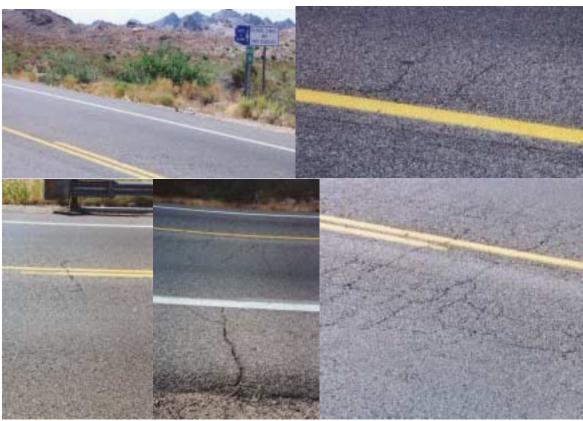
# FIGURE 9 SR 68, Bullhead City-Kingman, constructed 1991

the first five years after the one-inch AR-ACFC was placed and only 1% in the next three years. The ride is 75 with maximum rut depth of 0.27 inches. Maintenance costs have averaged less than \$150 per lane mile. The year 2000 inspection showed this highway still to be in excellent condition with a very low percentage cracking. The cracks that have reflected through are hairline and have not required maintenance. While this is a low traffic route, it is carrying a volume of 110,000 18 kip ESALs. Project performance data are available in Table 6 and photographs are displayed in Figure 9.

Top - 1990 road condition. Bottom 5 photos indicate some cracking but no maintenance. Lower Right - worst case of distress, usually on grades.

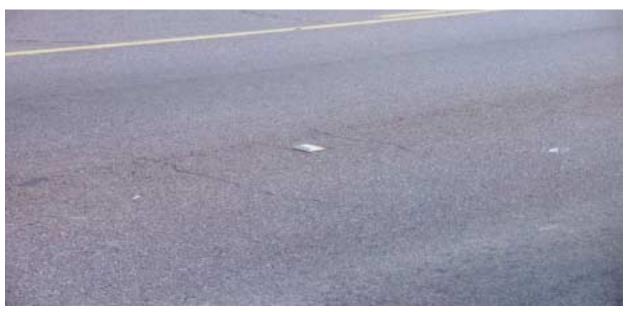
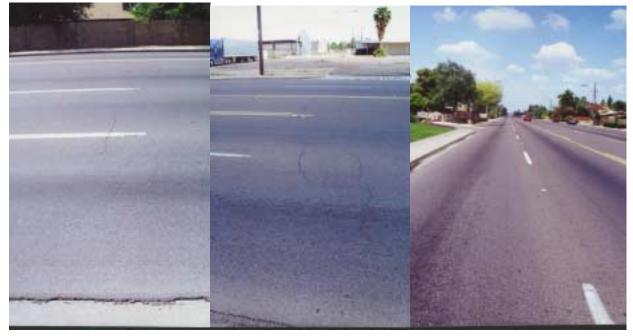
FIGURE 10 Glendale, 51<sup>st</sup> Ave, Northern – Butler, constructed 1991

This project is located within the City of Glendale, a northwestern suburb of Phoenix and was constructed in 1991. Although this project was administered by ADOT during design and construction it is not part of the ADOT system and no PMS data is available. This is a one-mile section of a four lane, arterial street with a continuous left turn lane in the center. It has traffic signals at each end and one at the half-mile intersection. Approaching and leaving the signalized intersections, transverse cracks are present in the southbound driving lanes at approximately twelve feet on center. These cracks are closed in the wheel paths and are narrow elsewhere

except for the turn lane where the cracks are a quarter inch in width. Moving away from the intersections, the cracking in the travel lane becomes less prominent. The cracks are hairline in nature, and stop entirely approximately 300 ft. from the intersection. In the continuous median, left turn lane, the cracks continue throughout the length the project. Some curling of the crack edges can also be noted in the median lane. Of further interest is that cracking in the travel lanes occurs only in the southbound lanes and not in the northbound lanes. Photographs of the project are displayed in Figure 10.

No photographs were available before 1991 construction. The first three photographs demonstrate transverse cracking patterns where the cracks are closed or nonexistent in the wheel paths. This cracking only appears near the intersections. No maintenance activities are evident. The photograph on the bottom right is typical of most of the project.

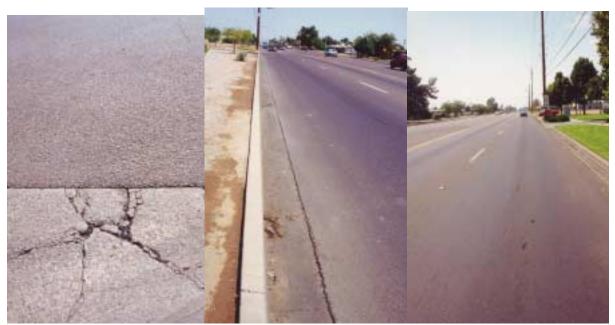
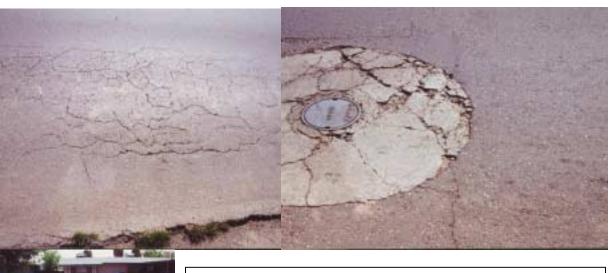
FIGURE 11 Glendale, Camelback Road, 43<sup>rd</sup> Ave. to 75<sup>th</sup> Ave, constructed in 1991

ADOT administered program. Likewise, no PMS data are available. As one would expect performance would be very similar. Photographs are in Figure 11. Transverse cracks have developed with approximately 15 feet centers in the median or center turn lane. The cracks are a quarter inch or greater in width and curling can be observed. Cracking in the travel lanes is limited to the stopping and starting areas and the cracks are hairline and fully closed in the wheel paths. The transverse cracks in the center lane do not appear in the travel lanes.

There is an area of fatigue failure in the westbound curb lane west of 55<sup>th</sup> Ave. This failure is localized, approximately 180 feet long and two feet wide. Soil strains from pumping and differential settlements are noted in this area. The cracks that have formed are a chicken wire pattern, 3-4 inches apart, and are hairline. There is no spalling and no pot-holing, however repairs should be made.

No photographs were available before 1991 construction. The three images on top are typical of most of the project with good crack resistance. One area of localized distress is noted, depicted in middle left photo. Middle right – good crack resistance around utility port. Bottom left - Transverse cracks are closed or nonexistent in the wheel paths.

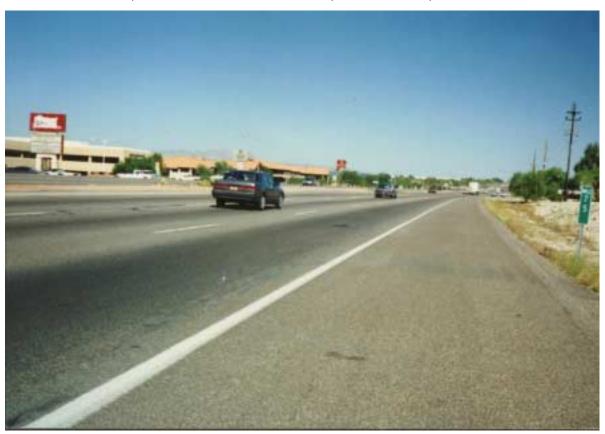
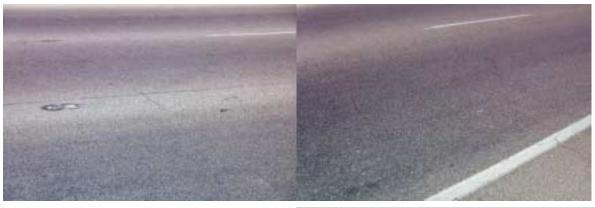
FIGURE 12 SR 77, Ina Road – Canada Del Oro, MP 74.9-79.1, constructed 1990

Before the overlay, this pavement had an extremely high maintenance cost of \$7971/lane mile, even though the percentage cracking was low (7%) and the ride was good (54). In the ten years since the overlay maintenance cost have averaged only \$394 per year. PMS data is presented in Table 7 below and photographs are in Figure 12.

Top – Roadway prior to overlay in 1990 Bottom Three Photos – Typical cracking patterns after ten years of service, noncontinuous transverse cracking closed in the wheel paths.

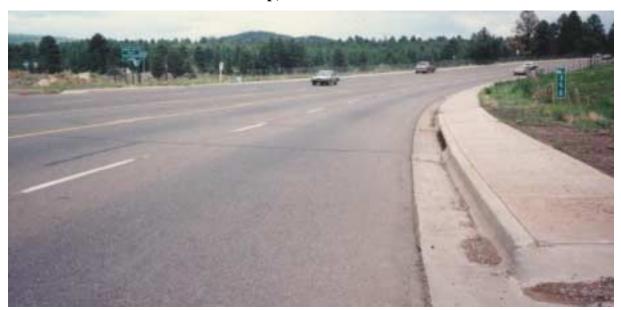
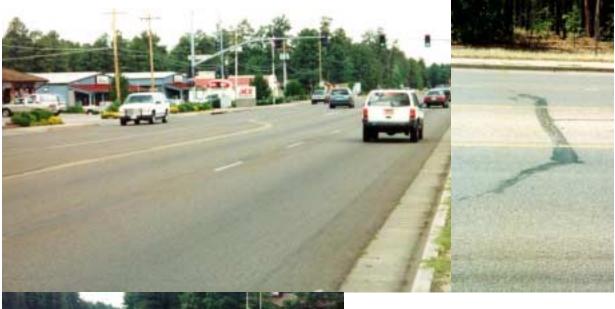
FIGURE 13 SR 260 Lakeside – Pinetop, MP 351-354 constructed 1991

In the Eastern ½ mile of the project both longitudinal and transverse cracking have developed. The transverse cracks are spaced at approximately 20 feet and are ¼ inch to ½ inch wide in the travel lanes. These cracks have been sealed by maintenance. These cracks are not spalling, warping or cupping is not evident, and the ride is still excellent.

The rating for this ½ mile would have to be fair to good with the remaining 2½ mile, considered in excellent condition. Performance data is listed in Table 8 and photographs are available in Figure 13.

Top – Before construction Middle and Bottom Left – Year 2000 review typical project view. Middle Right – Some transverse cracking on Eastern end of project apx. 20 feet spacing, sealed by maintenance.

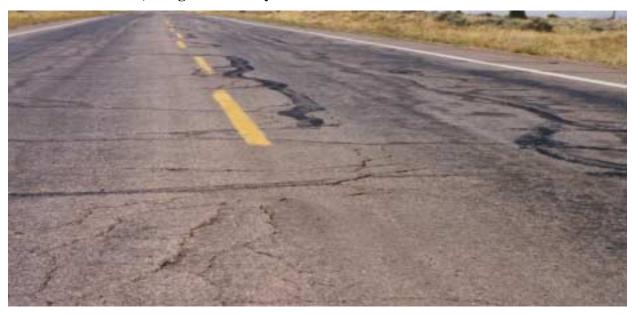
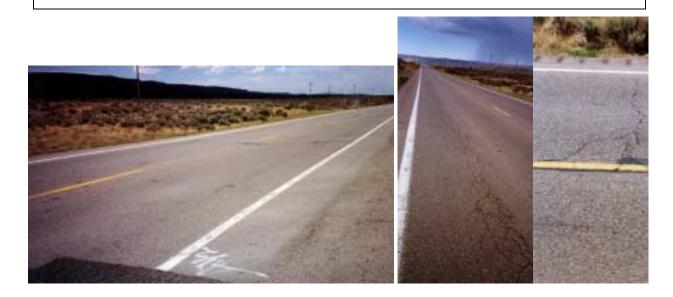
FIGURE 14 SR 160, Longhouse Valley MP 365.0-372.5 constructed 1988

Traffic is moderate at 90,000 ESALS/years. Approaching this project from the west on a conventional AC material, there is extensive, wide, transverse, and longitudinal cracking. The ride is very rough and each transverse crack can be distinctly felt. The transverse cracks are about 50 feet apart, one inch (plus) in width, are spalling, and curling downward. These cracks have been sealed but the ride is unpleasant and sufficiently rough to probably result in increased operating vehicular operating costs.

Within the project, some cracking exists in the overlay. For the most part this consists of transverse cracks approximately 40-50 feet apart, ¼ inch wide in shoulder area and closed in the traffic lanes. There is no spalling or curling evident and with very few exceptions, there has been no maintenance. Near the center of the project, Peabody Coal Company has a terminal. West of this in the westbound lane there exist some fatigue cracking. These chicken wire cracks are hairline in nature, and are not spalling. This area probably will require some maintenance expenditure in the near future. In the west three-miles of the project are areas of transverse cracking, 1/8-1/4 inches wide but closed in wheel paths. No curling, no spalling, or raveling has occurred. All in all, after 11 years of service, this pavement is still in excellent condition. The

Top – Typical road condition prior to overlay, 22% cracking. Below Right – Typical condition of overlay after 11 years. Below Middle – Localized area of fatigue near coal company terminal. Below Left – Transverse cracks spaced 50 feet apart, total project rated at 6% cracking.

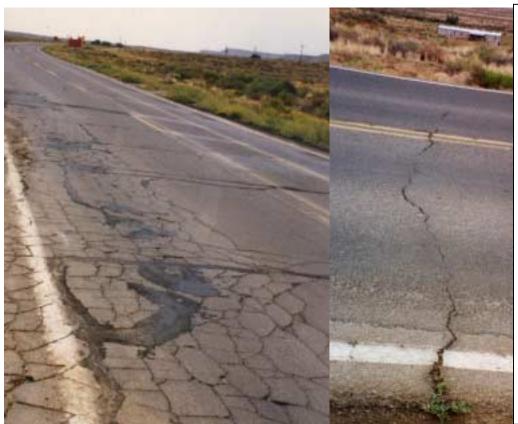
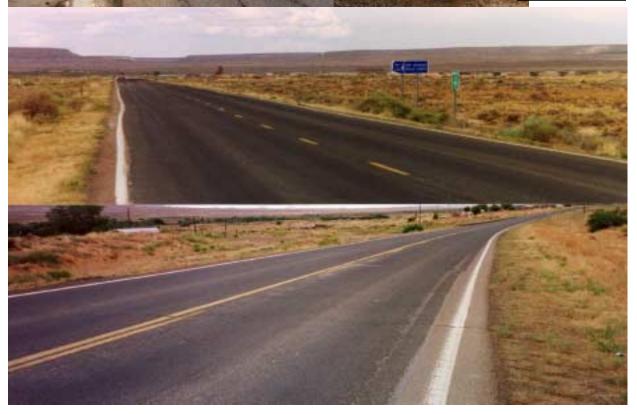
FIGURE 15. SR 264, Route 77 to Pollaca Wash MP 384.8-392.3 constructed 1989

Far Right -Conditions prior to overlay in 1989, 10% cracking. Near Right – Transverse shrinkage cracks with 35 foot spacing, 7% cracking after 11 years. Below -Typical project views, rejuvenating agent applied in 1998 probably due to low binder content in overlay (6.5%)

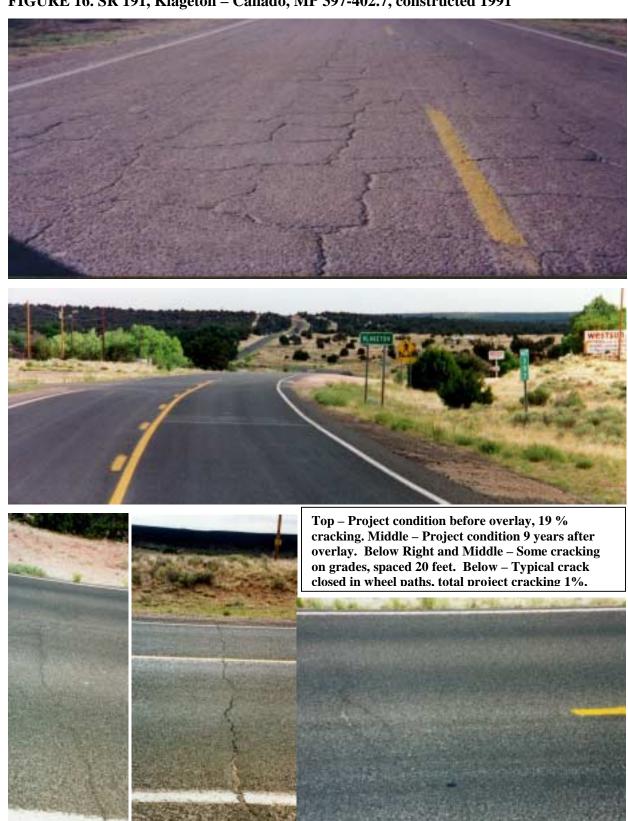
FIGURE 16. SR 191, Klagetoh – Canado, MP 397-402.7, constructed 1991

In the year 2000 the observations were noted. Each end of the project is in a terrain of rolling hills. In these areas transverse cracks have developed at approximately 20 feet centers. The cracks are ¼ - ½ wide in the non-traffic areas and are hairline or less than 1/8 inch in the wheel paths. The center section of the project lies in a broad valley which is relatively level. In this section very few cracks exist and are less than 1/8 inch. Two possible explanations of this behavior would be that the level areas had lower stress both from environmental and traffic applications from the areas on the grades. It is also possible that during construction those sections on grades were not as well compacted and the pavement experienced slightly more aging. After nine years of service in fairly severe climatic conditions, this pavement is still in good to excellent condition.
